PLATE II

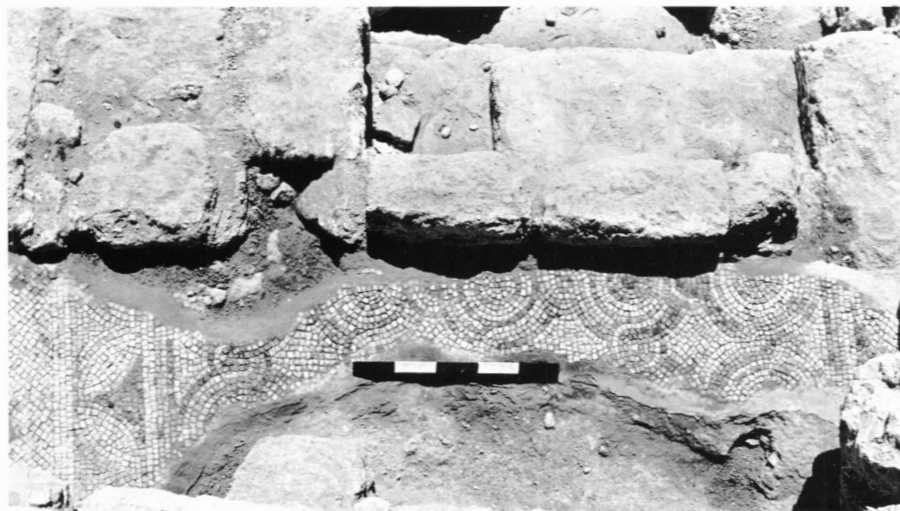
B. Fragment of the multicolored mosaic floor of the Byzantine church in Square A.5. Photo: Avery V. Dick.

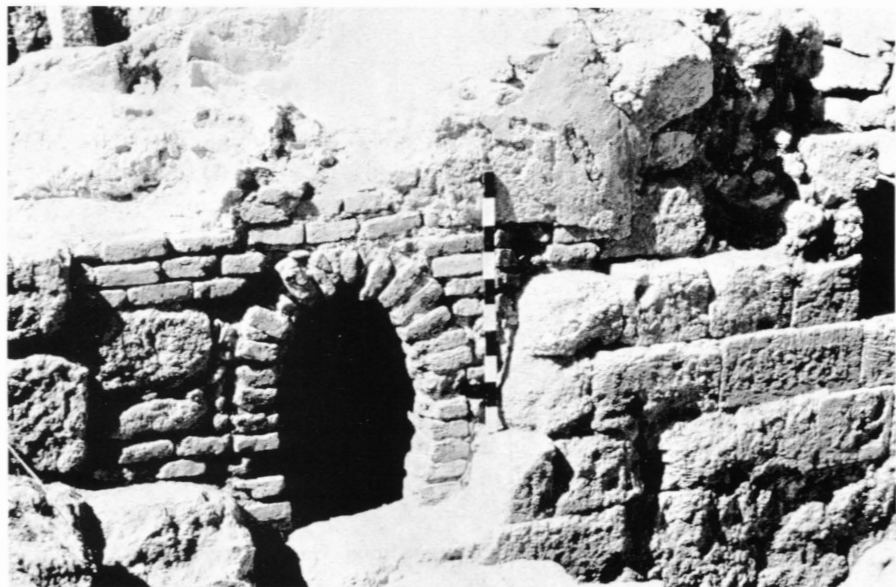
A. The opening of the furnace of the Islamic bath in Square A.7. Photo: Abu Hannah.

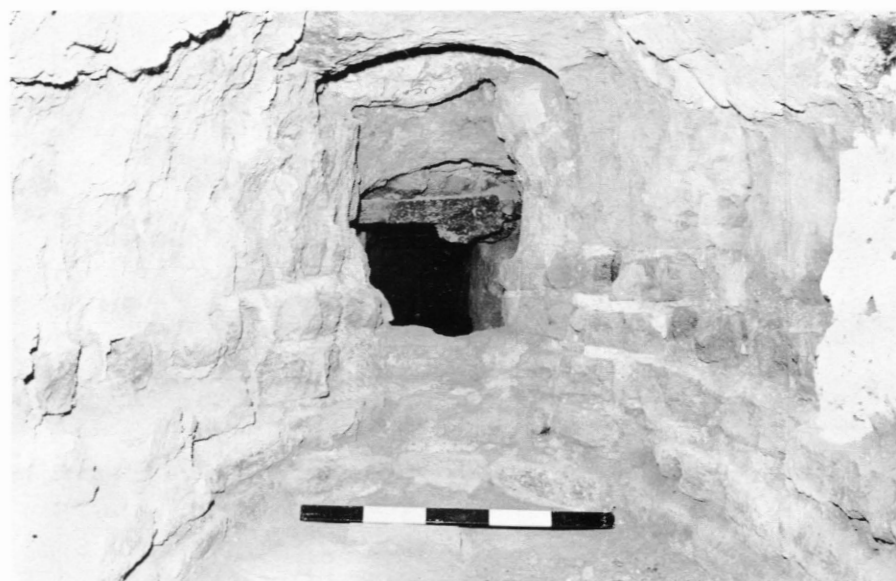
B. The inside of the furnace looking toward the horizontal flue which begins at the hole in the background. It heats the bathing room above. The edge of a black basalt slab is visible on which the floor tiles rest. Photo: Avery V. Dick.

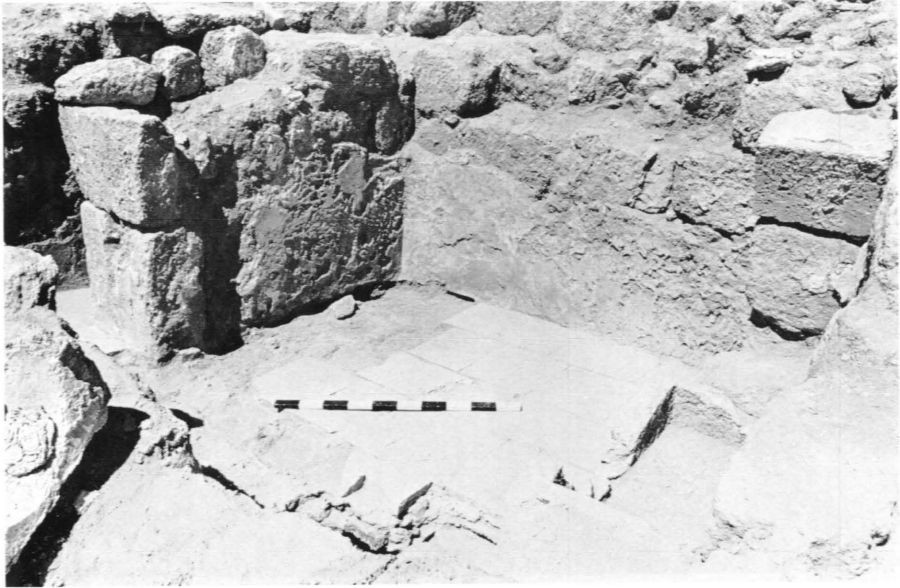
A. The bathing room of the Islamic bath in Squares A.7 and 8. The meter stick lies on the tiled floor. To its left is Wall A.8:2 which contains the Chimney A.8:10.
 Photo: James H. Zachary.

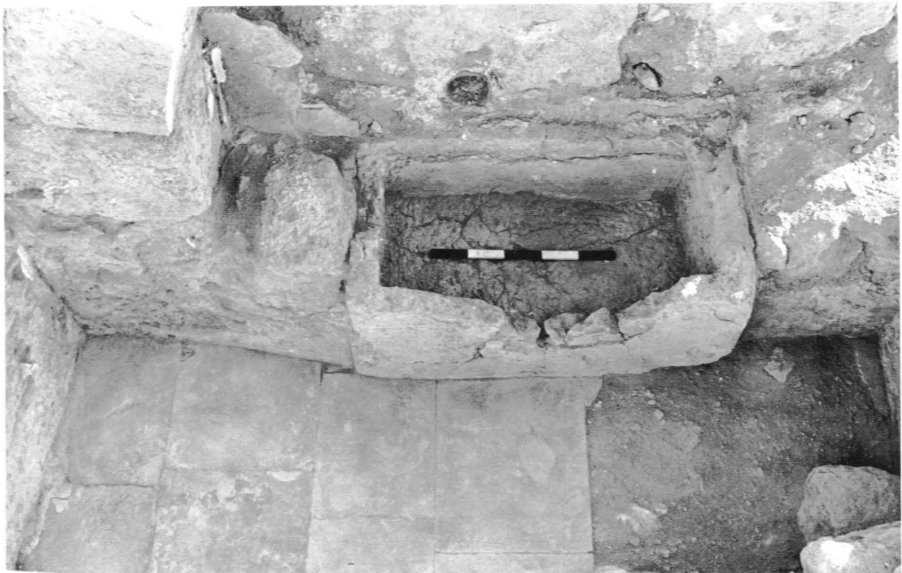
B. The water basin of stone in the bathing room. Above the basin are the outlets for the hot water (left) and the cold water (right). Photo: Avery V. Dick.

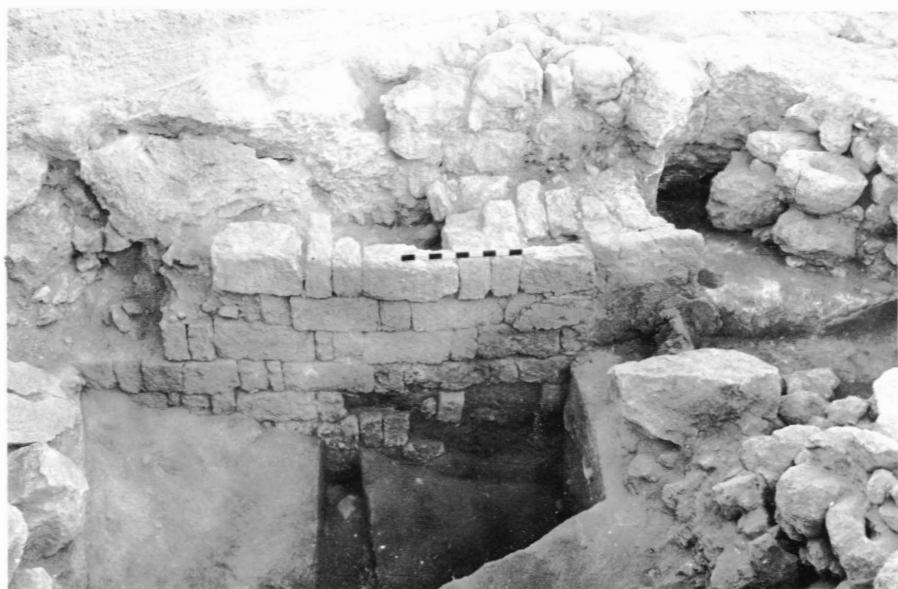
A. The header-stretcher Wall B.2:84 in Square B.2 which was probably the eastern retaining wall of a large open-air water basin. Note the remains of plaster at its southern end near the center in the picture. Photo: Avery V. Dick.

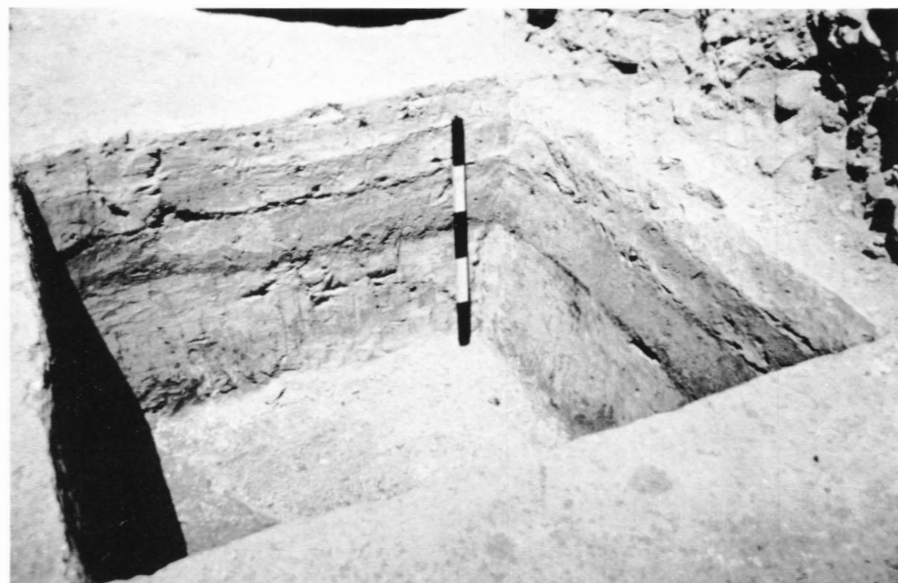
B. A one-meter square probe through the plaster at the bottom of Square B.1. Notice the three distinctive layers of plaster, each about 10 centimeters thick. The plaster layers rest on limestone bedrock which for control purposes was penetrated for ca. 30 centimeters to make sure bedrock was actually reached. Photo: James H. Zachary.

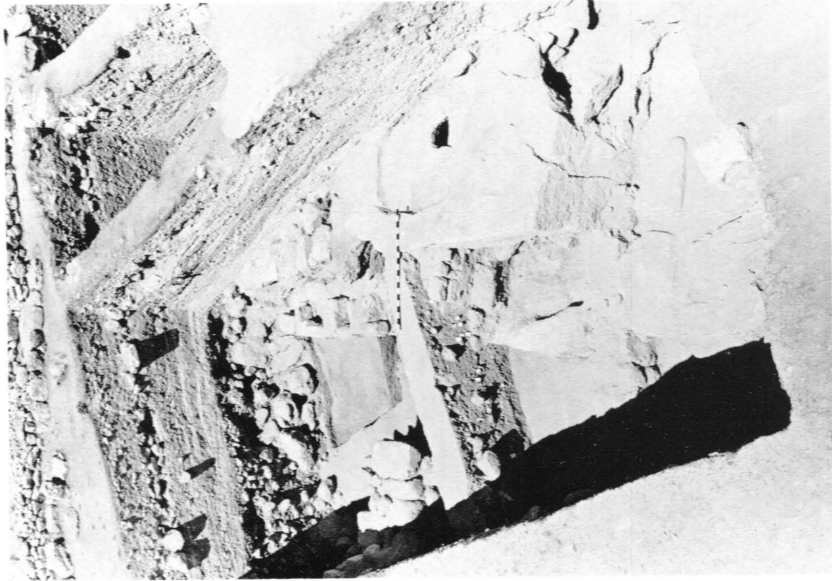
A. The header-stretcher Wall B.2:84 can be seen above the left end of the meter stick. The latter rests on the balk. The continuation of Wall B.2:84 is seen in Square B.4. In the foreground is the large Rock B.4:168 with water channels carved into it. Photo: Paul J. Bergsma.

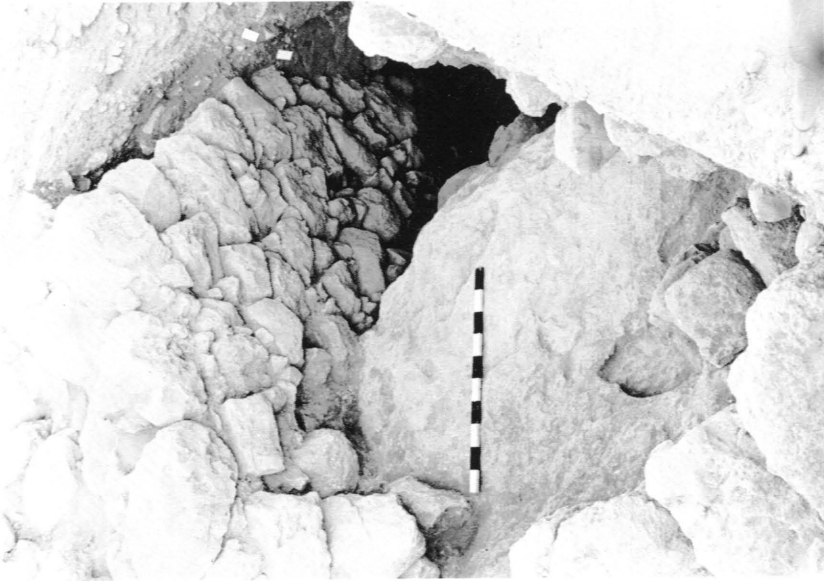
B. The possible Iron Age city Wall C.3:34/28 (in the lower left corner) and its Bastion C.3:32/26, jutting out to the west (above). The meter stick lies on the same bedrock on which the structures rest. Photo: Paul J. Bergsma.

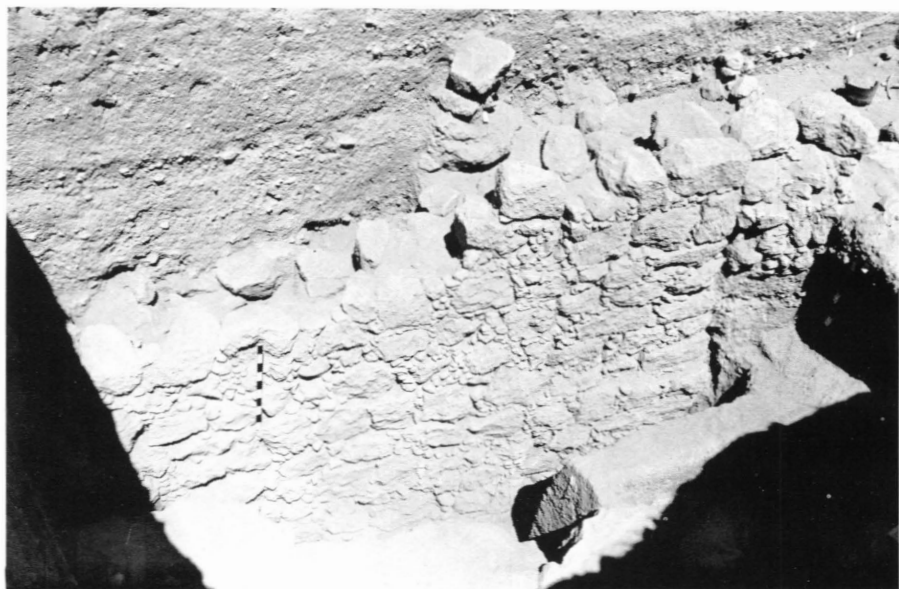
A. Fragment of the Roman Tower C.1:40 in Square C:1. A later wall (C.1:30) abuts it on the right. Photo: Paul J. Bergsma.

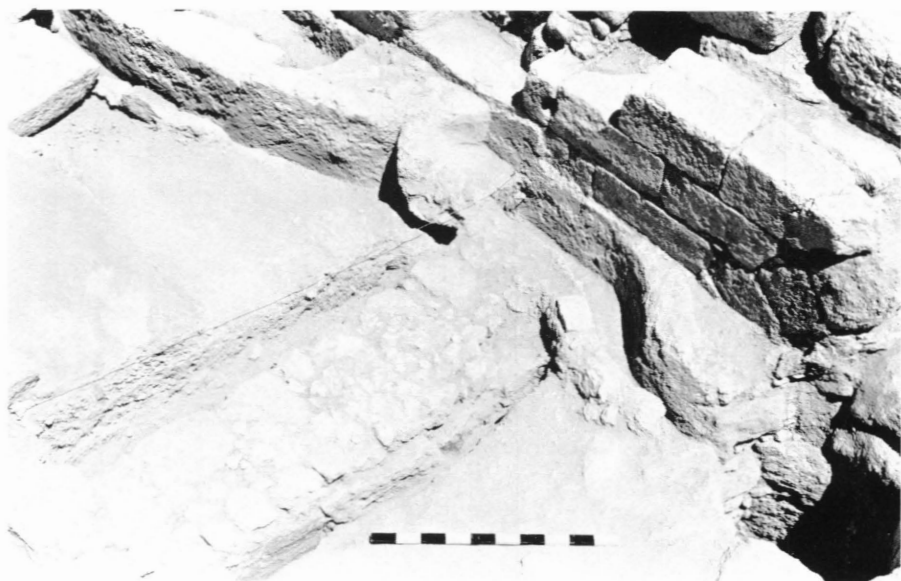
B. The southern exterior wall (D.5:12 = D.6:55) of the Byzantine church is in the upper right part of the picture. Notice its doorway and arch over Cistern D.6:33. Flowing into the cistern from Catch Basin D.5:31 is Channel D.6:63. Channel D.5:20 flows in opposite direction toward Cistern D.5:5 (not shown in this picture). Wall D.6:56b runs to lower left. Photo: Paul J. Bergsma.

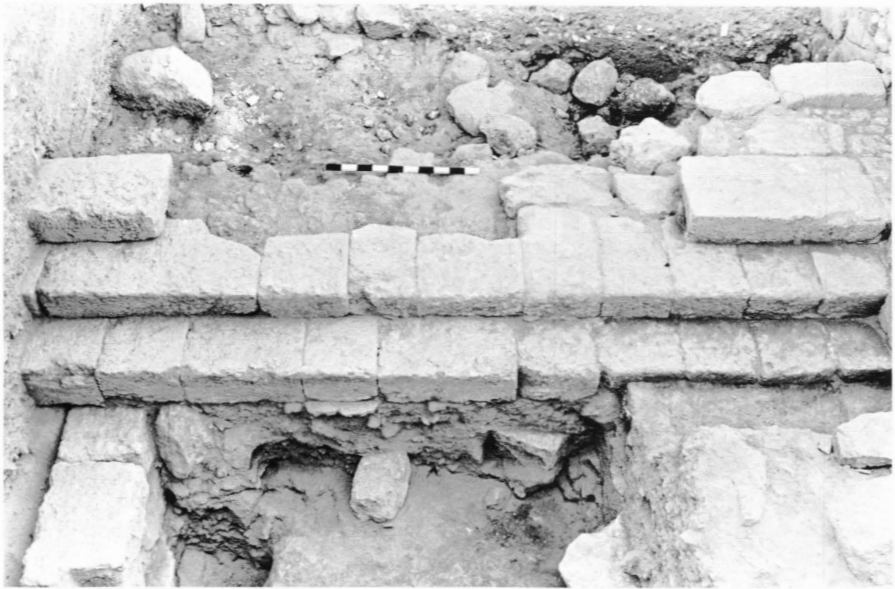
A. Southern end of monumental Late Roman Stairway D.3:39. Excavation in lower left has gone below Surface D.3:44 associated with stairs to expose Wall D.3:47a at left and earthquake-damaged slabs of bedrock in center. Photo: Avery V. Dick.

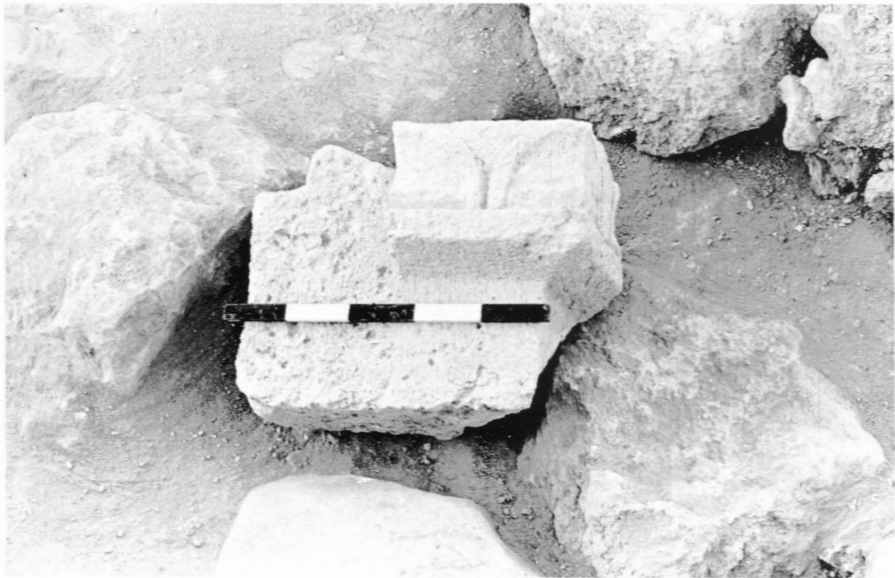
B. Carved stone which originally had crowned the southern end of the balustrade of the Late Roman Stairway D.3:39. Photo: James H. Zachary.

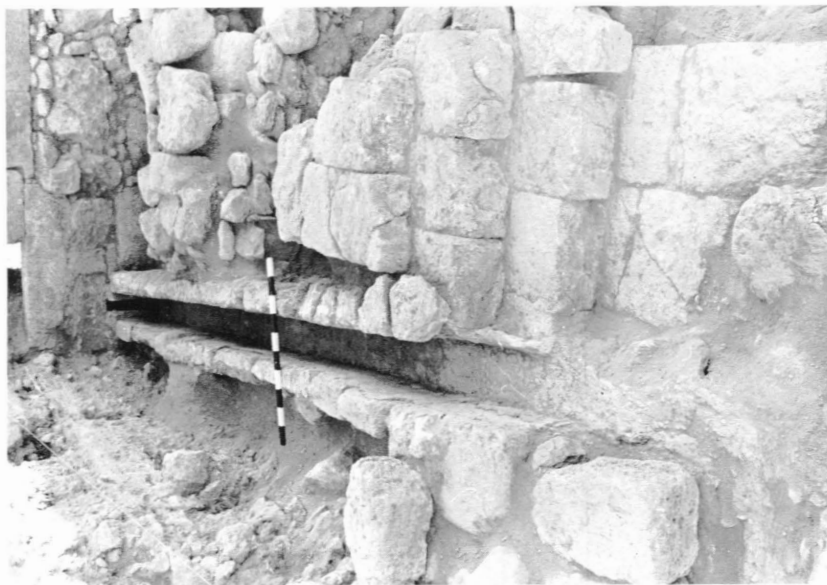
A. Water Channel D.1:58 = D.2:30 running from beneath gateway through Wall D.1:4c in the background to Stairway D.2:32 (on right), Stairs D.2:7b (on left), and Stairs D.2:34 (bottom left). Photo: Avery V. Dick.

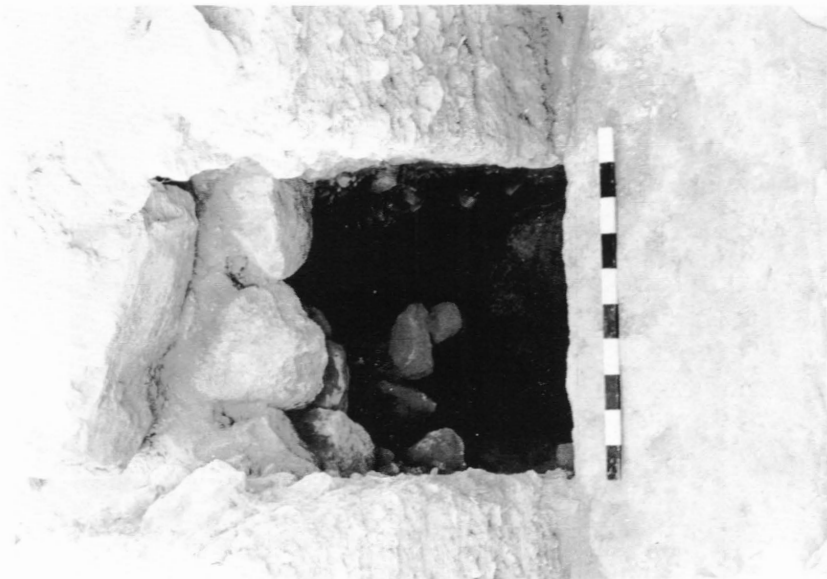
B. Probe in south balk of Square D.1 showing the back of Wall D.2:21/26 battered up against Hellenistic soil layers which covered the artificially-cut shelf of bedrock on which the meter stick rests. The base of Wall D.1:4d is visible at bottom. Photo: James H. Zachary.

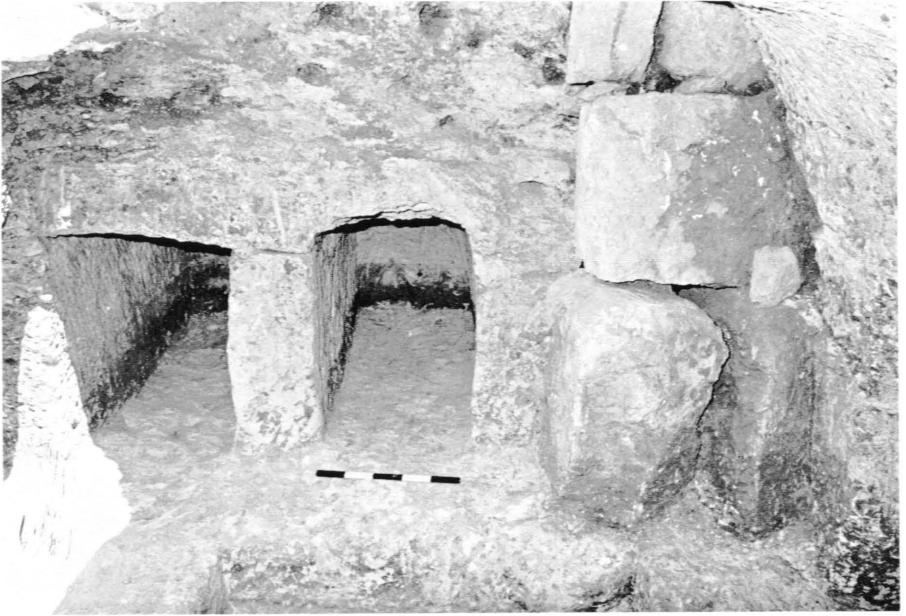
A. The stone shoring in the southeast corner of Tomb F.14. The shoring covers the openings to Loculi 3 and 4. Loculi 5 and 6 are visible at the left of the shoring. Photo: James H. Zachary.

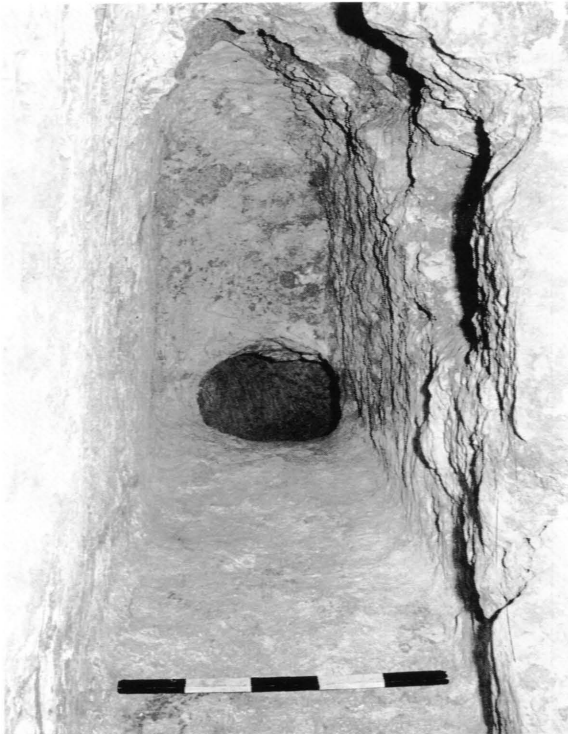
B. Looking into Loculus 9 of Tomb F.14 which shows the break-through to Loculus 5 of Tomb F.18. Photo: Avery V. Dick.

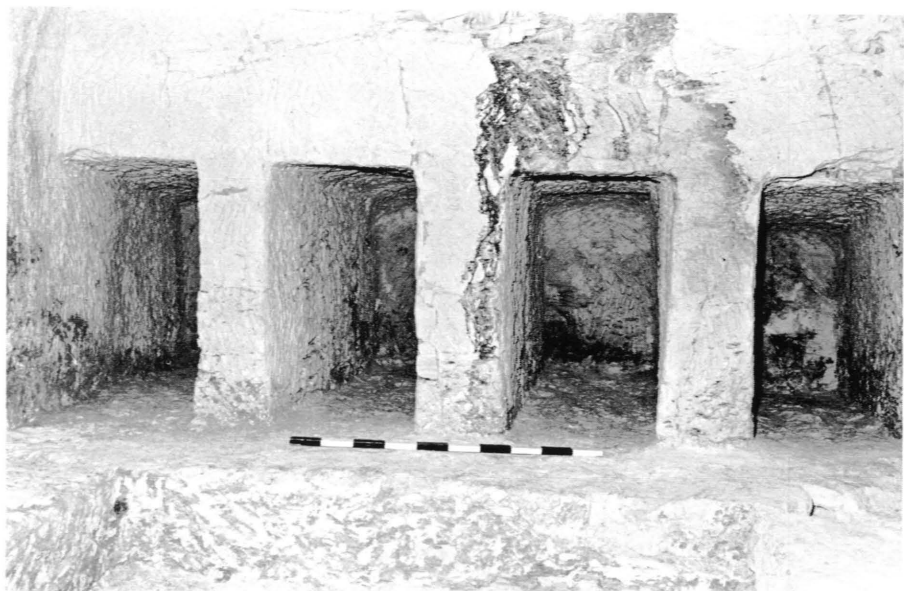
A. Loculi 9-12 of Tomb F.18. Photo: Paul J. Bergsma.

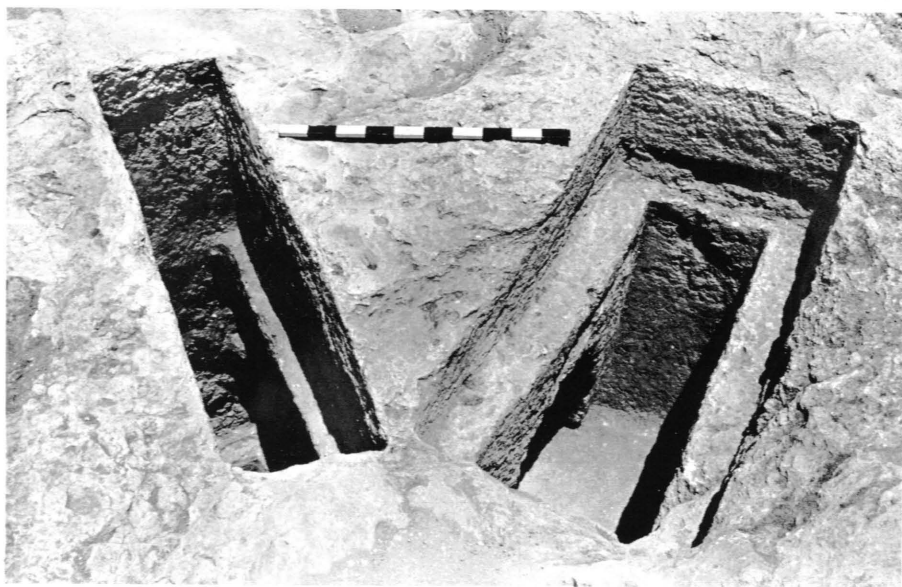
B. Byzantine shaft Tombs F.15 (right) and F.17. Photo: Paul J. Bergsma.

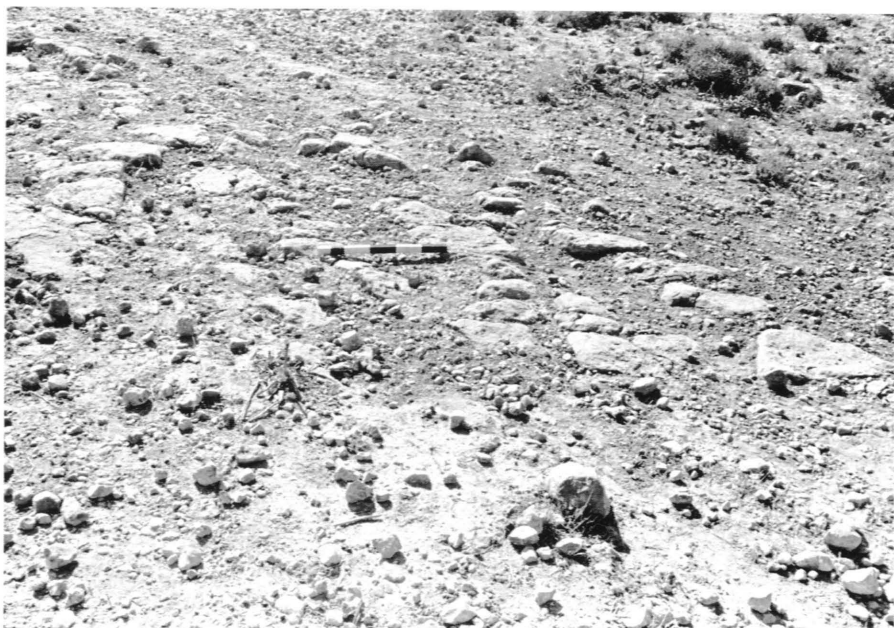
A. Cobble stones of the Roman road east of Site No. 35 (Grid Reference 2196.1341).
Photo: Avery V. Dick.

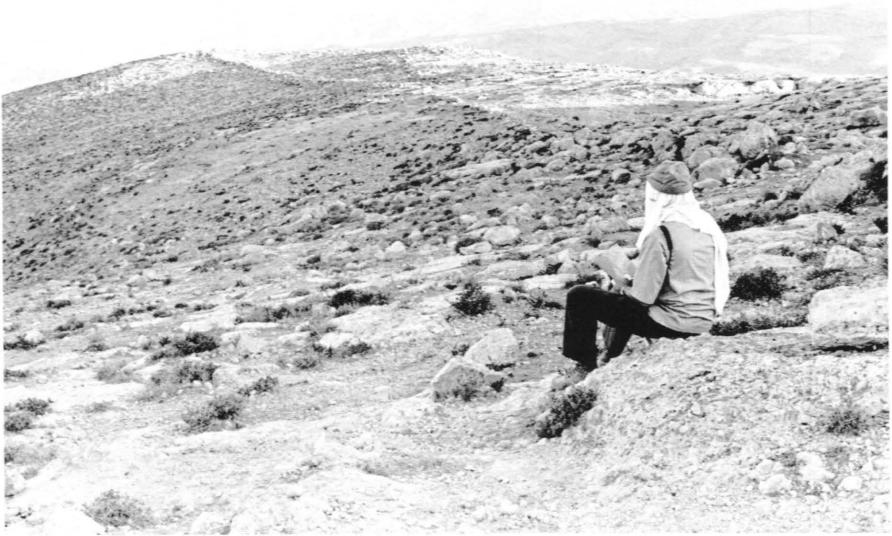
A. A sector of the Roman road. It begins in the picture at the right (above the man's head) and goes toward the upper left until it is lost over the ridge. Photo: Avery V. Dick.

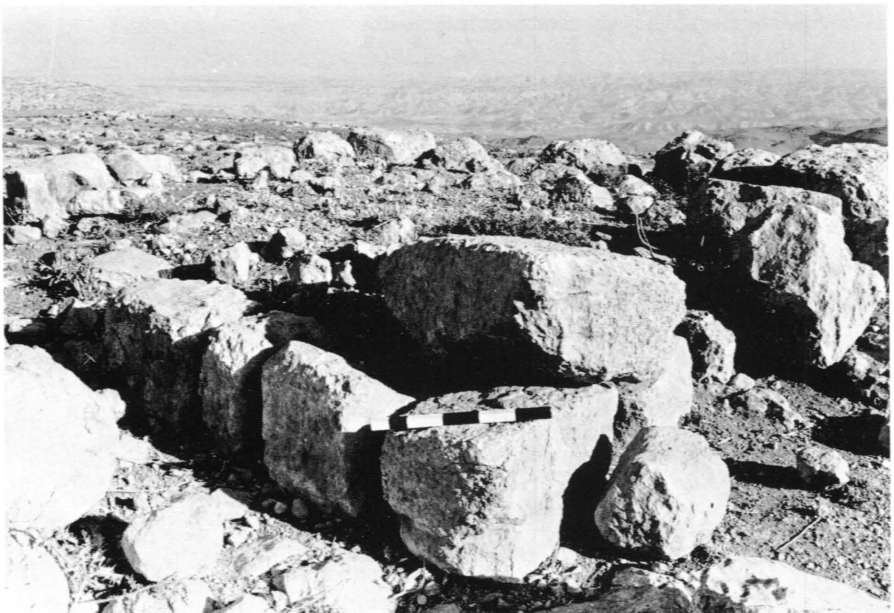
B. The remains of a square structure of Roman times, probably a road station. Photo: Avery V. Dick.
